# SRS AIRBAG SYSTEM

## SRS AIRBAG SYSTEM

### IMPORTANT SAFETY NOTICE

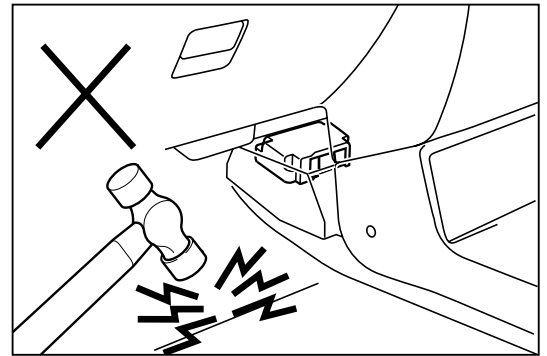
YAB00006

- During installation or replacement, do not bump the area near the airbag ECU, using an impact wrench, a hammer or the like. It may cause the sensor in the ECU to operate.

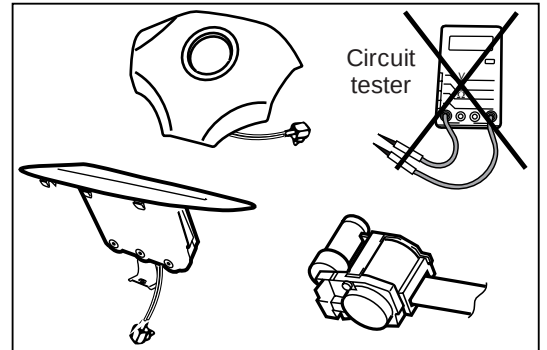
YAB00007

- To prevent the airbag unit or the pretensioner from deploying, do not measure the resistance of the inflator squib easily.

The squib of the airbag or seat belt pretensioner consists of a filament of about 2 ohms. Therefore, there is the possibility that a current which is big enough to cause deployment flows when ohmmeter is connected.

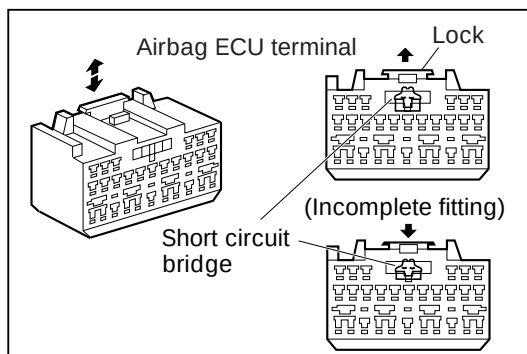
YAB00032

This mechanism is provided at the connector for airbag ECU. This mechanism detects electrically if the connector is connected completely. When the connector is fit completely, the detecting terminals at the ECU side and detecting pins at harness connector side are connected, allowing a small amount of current to flow to the ECU and warning lamp circuit. In this way, the fitting condition is monitored.

If the connector is connected incompletely, the detecting pins and terminals don't contact.

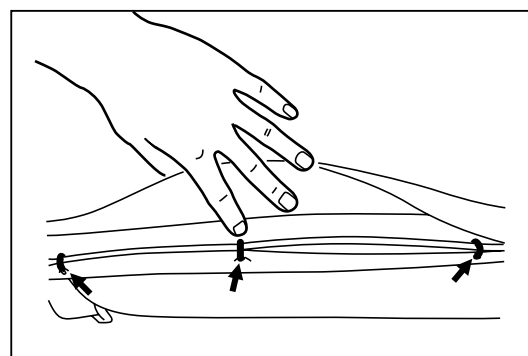
YAB00113

5. Turn over the seat cover, until the side airbag unit can be seen, by removing the hug rings (three points) at the lower part of the seat back.
6. Remove the side airbag unit by loosening the attaching nuts.

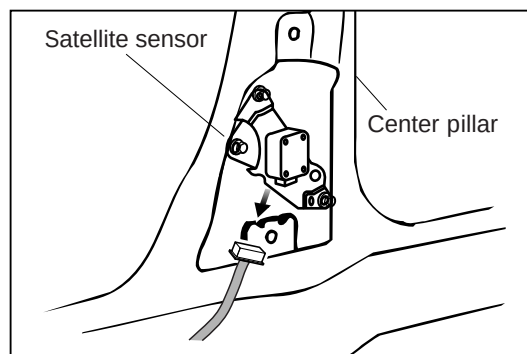
YAB00134

- Remove the satellite sensor by loosening the attaching bolts

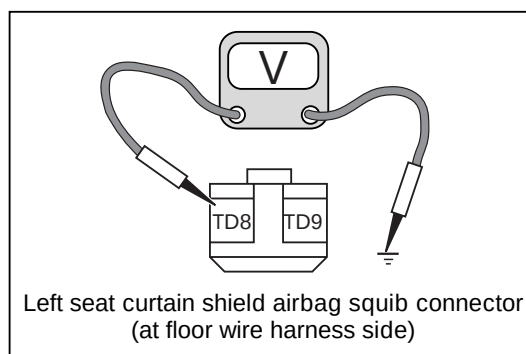
YAB00507

Left seat curtain shield airbag squib connector (at floor wire harness side)

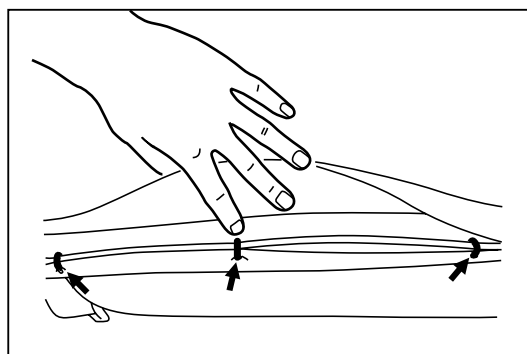
YAB00623

4. Turn over the seat cover, until the side airbag unit can be seen, by removing the hug rings (three points) at the lower part of the seat back.
5. Remove the side airbag unit by loosening the attaching nuts.
